Metallurgical Examination of a Failed Blade Lag Shock Absorber (Part No. 114H6802) From a CH-47D Chinook Cargo Helicopter

ARL-TR-2191

March 2000

Marc S. Pepi, Scott M. Grendahl, and Victor K. Champagne
Weapons and Materials Research Directorate, ARL

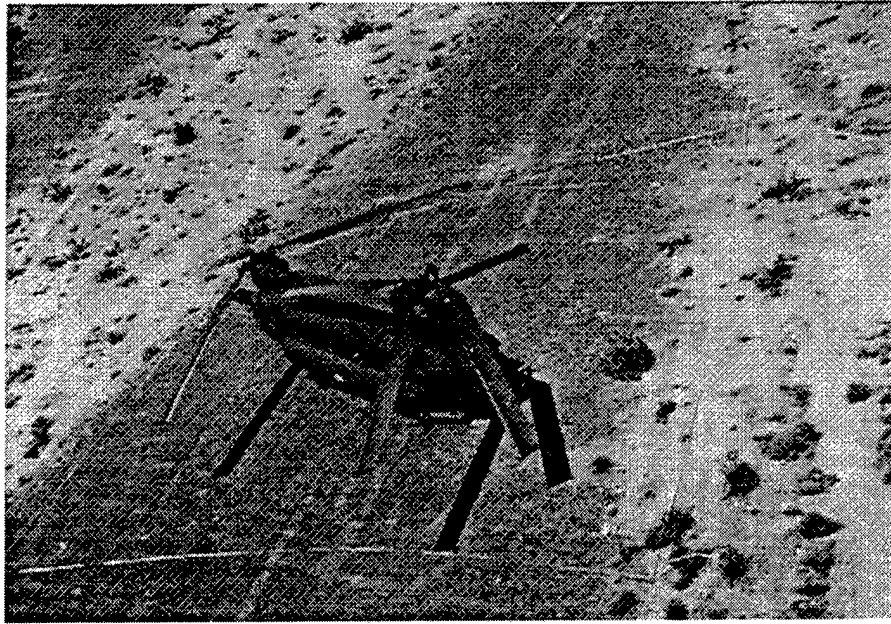
Figure 1. Overhead View Showing the Damage Encountered by the Chinook Helicopter Subsequent to the Failure of the Blade Lag Shock Absorber (Photo Courtesy of CCAD).

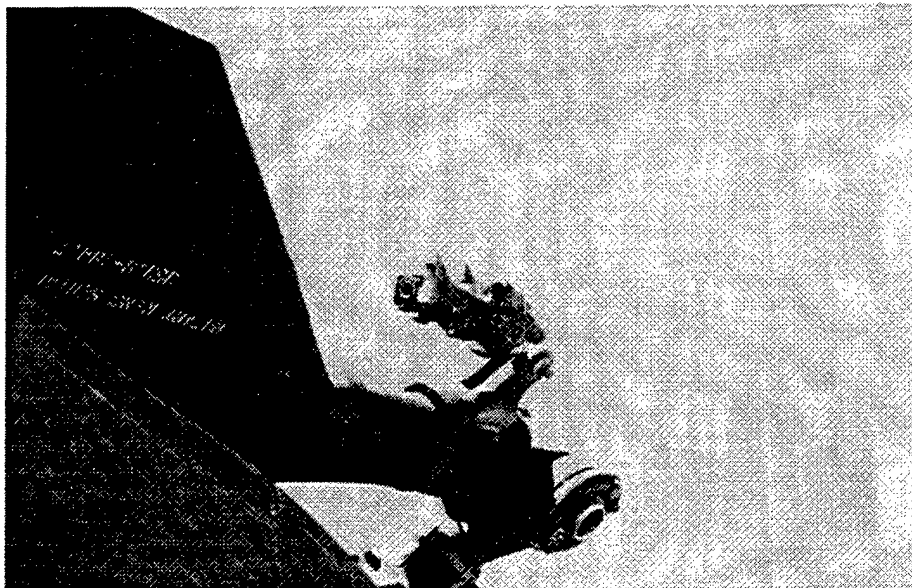
Figure 2. View Showing the Extensive Damage at the Aft Rotor, Caused by the Blade Lag Failure (Photo Courtesy of CCAD).

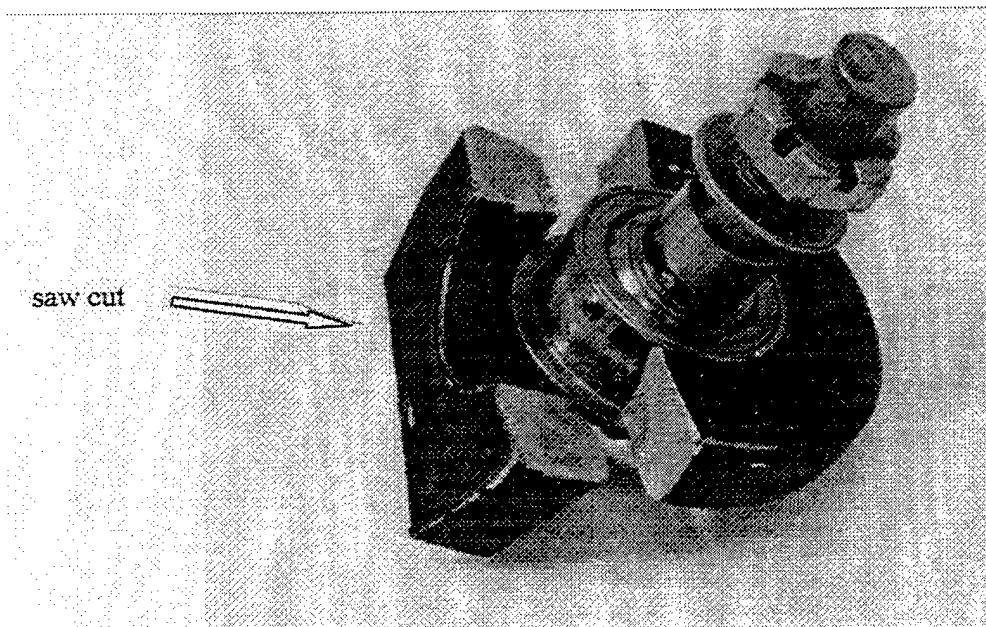
The failed part was visually examined at Boeing. The inboard lug had two radial through-fractures at the spherical bearing bore, as shown in Figure 8 [1]. The through-fractures were at the approximate positions shown in Figure 9 of the inboard lug of the blade lag shock absorber:

Figure 8. Failed Component Taken From the Lag Blade Shock Absorber (Photo Courtesy of CCAD).

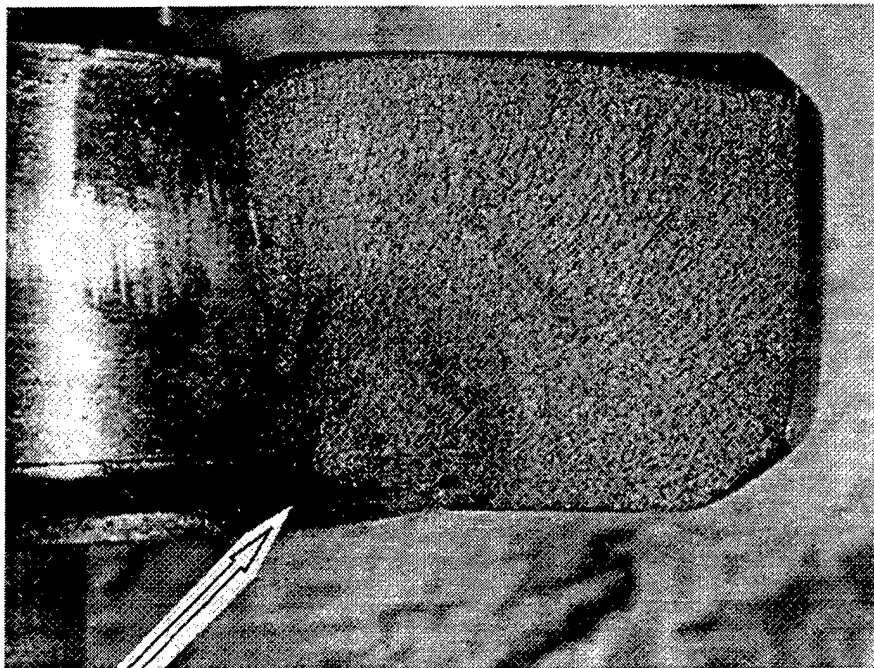
Fluorescent penetrant inspection performed by Boeing revealed no additional cracks. Figures 10 and 11 [1] show the primary and secondary fracture surfaces, respectively. The primary fracture (labeled as Fracture A within the context of this report) exhibited features consistent with a fatigue failure; the topography was relatively flat and smooth, with evidence of beach marks. The fatigue crack traversed approximately 95% of the fracture surface through the lead portion of the lug, while ductile shear lips comprised the remaining fracture surface. This was considered the primary fracture surface due to the extent of fatigue. The origin was determined to be located at the top of the 0.040-in, 45° chamfer. The secondary fracture (Fracture B) contained only approximately 20% fatigue through the lag region of the part, with the remainder exhibiting a ductile dimpled morphology. The origin of this fracture was determined to be located along the bore, approximately 0.05 in from the spot face of the lug. In addition, a dark-gold coating was observed along the exterior of the part. This coating was the typical color of a part that had been chromic-acid-anodized (as required in accordance with the engineering drawing). A blackish-green coating was observed on the bore surface, which was atypical of the chromic acid anodize. Finally, many axial score marks were noted on the bore surface. Some markings were shiny, while others contained the blackish-green coating. These markings were determined to be consistent with the prior removal of the bushing. The blackish-green coating and the axial score marks were evidence that the bore had been reworked.

Figure 10. Optical Macrograph of the Primary Fracture (Photo Courtesy of CCAD).

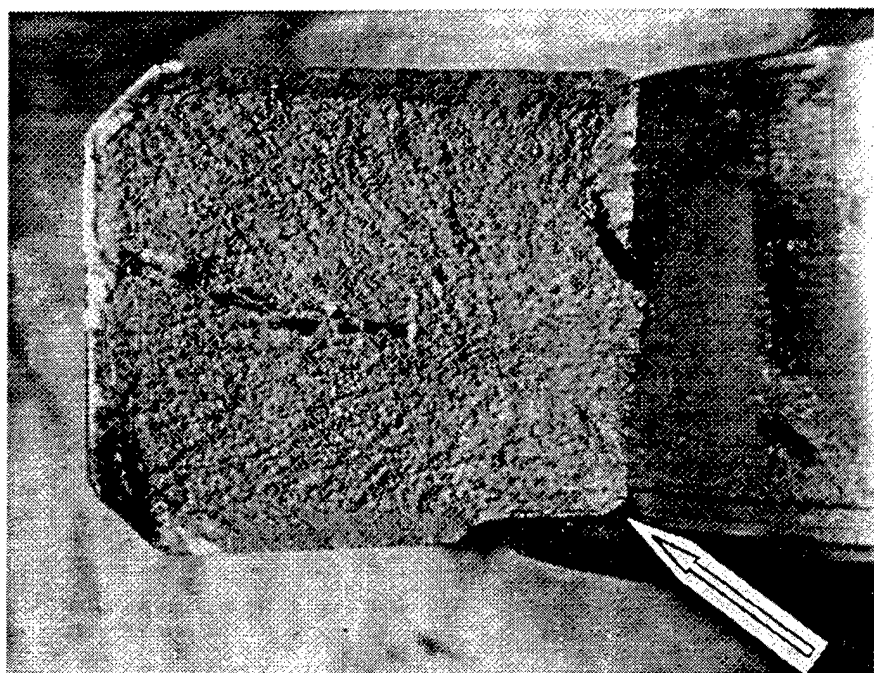
Figure 11. Optical Macrograph of the Secondary Fracture (Photo Courtesy of CCAD).

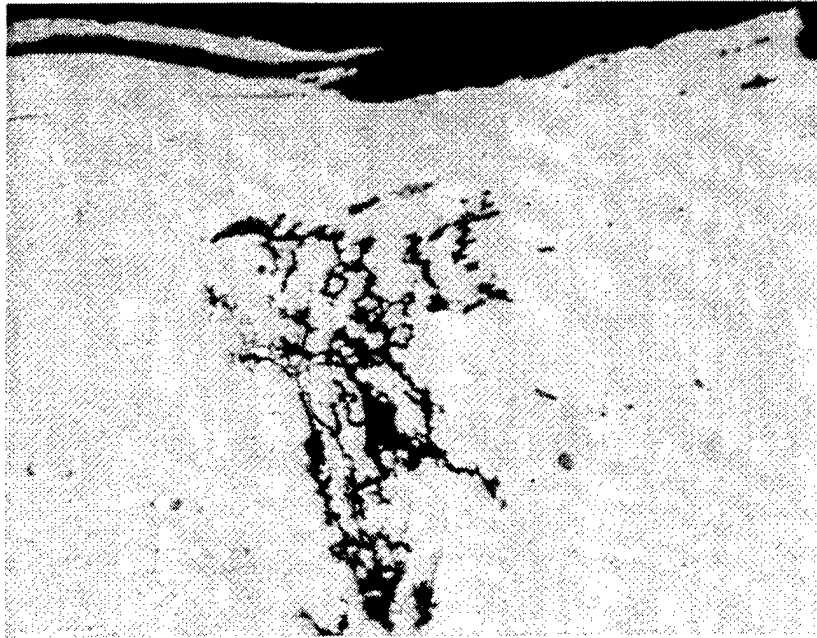
Boeing fabricated three transverse metallographic samples from the inboard lug. Evidence of intergranular attack was prevalent on each sample, extending along the bore wall and spot face of the lug. Figures 12 and 13 show examples of this corrosive attack in the as-polished condition, while Figure 14 shows another region of attack that had been etched with Keller's reagent. These areas of attack were located adjacent to the primary fracture. The average depth of the intergranular attack was approximately 0.010 in. The microstructure was examined in an effort to confirm that the part was properly aged to the -T73 condition. The major microstructural difference resulting from variations in time and temperature of -T73 tempers is the size and type of precipitate. However, these differences are subtle, and impossible to detect metallographically [6]. Moreover, transmission electron microscopy (TEM) is not adequate in distinguishing between these features. It is suggested within Davis [6] that the differences within a given temper (and between tempers) be established through hardness, conductivity and, in some cases, tensile yield results. The -T73 temper contains a mixture of η' and the stable, incoherent η (MgZn_2) phase [7]. Figure 15 shows the precipitates of a sample sectioned through the chamfer in the as-polished condition. The light-gray particles were actually copper in color and represented the copper in the alloy. Figure 16 shows this structure etched with Keller's reagent at 200 \times magnification. Note the directionality of the grains, indicative of the prior forming operation. Figure 17 shows this structure at higher magnification.

Figure 12. Intergranular Attack Noted Along the Bore From a Sample Taken Adjacent to the Primary Fracture Surface; as Polished, Magnification 400 \times .

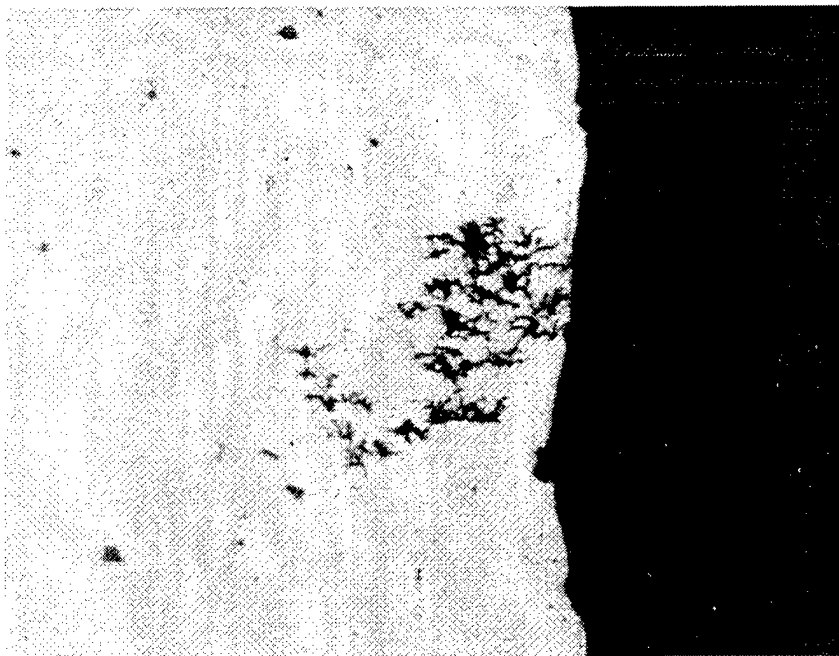
Figure 13. Another Region of Intergranular Attack Noted Along the Bore From a Sample Taken Adjacent to the Primary Fracture Surface; as Polished, Magnification 200 \times .

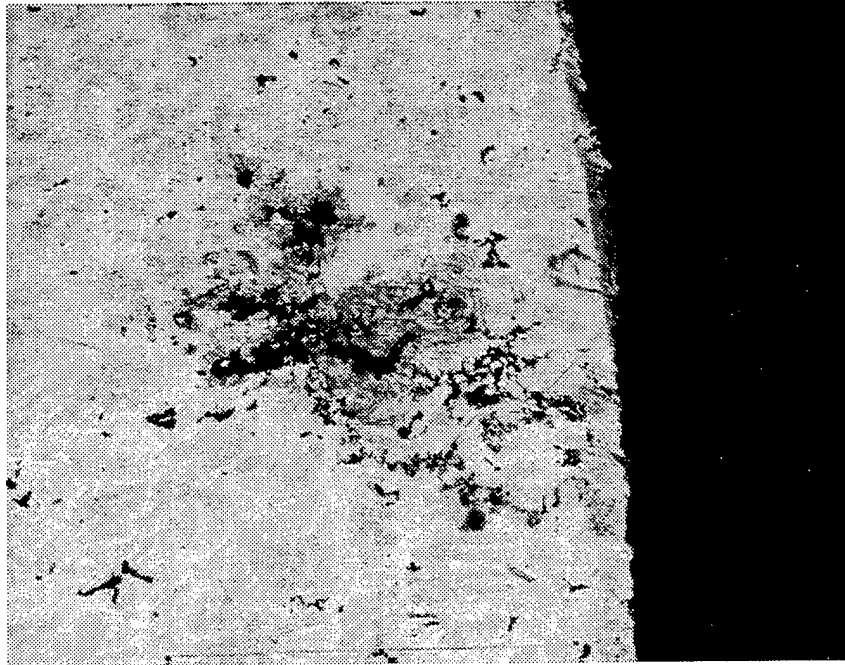
Figure 14. Intergranular Attack Noted Along the Bore of a Sample Taken Adjacent to the Primary Fracture Surface; Keller's Etch, Magnification 200 \times .

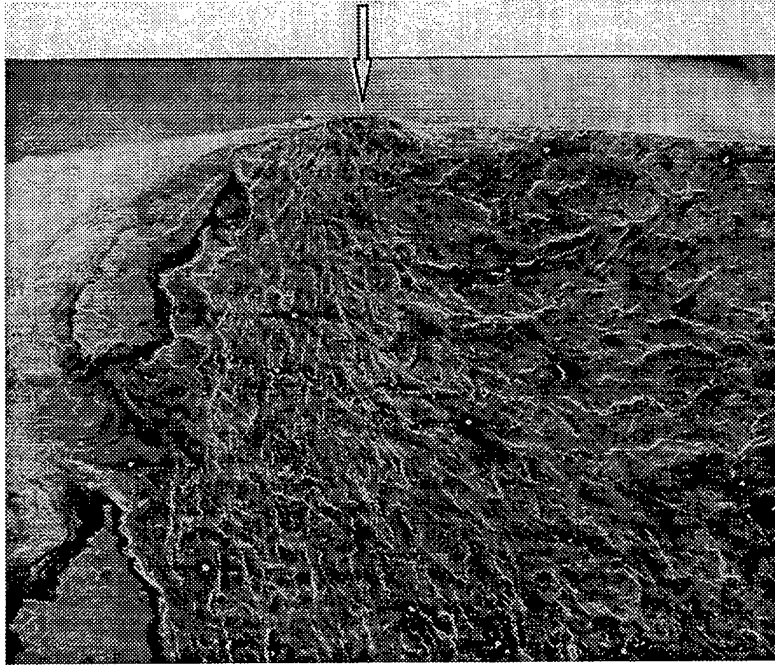
Boeing analyzed the fracture surfaces utilizing scanning electron microscopy (SEM). The results confirmed the origin locations, the fatigue failure mode, and the degree of fatigue crack propagation. Subsequently, ARL examined the fracture surfaces to more fully document the findings. The origin of the primary fracture is shown in Figure 18. The radial lines converge at the origin on the surface. Figure 19 shows the origin at an angle such that the bore can be seen,

Figure 18. SEM Macrograph of the Primary Fracture Origin (Indicated by Arrow); Magnification 50x.

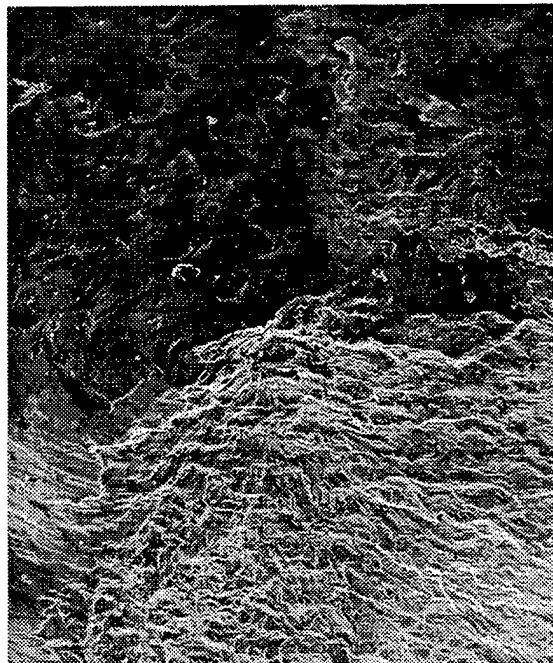
Figure 19. SEM of the Fracture Origin of the Primary Fracture, Tilted at an Angle to Reveal the Surface of the Bore; Magnification 50x.

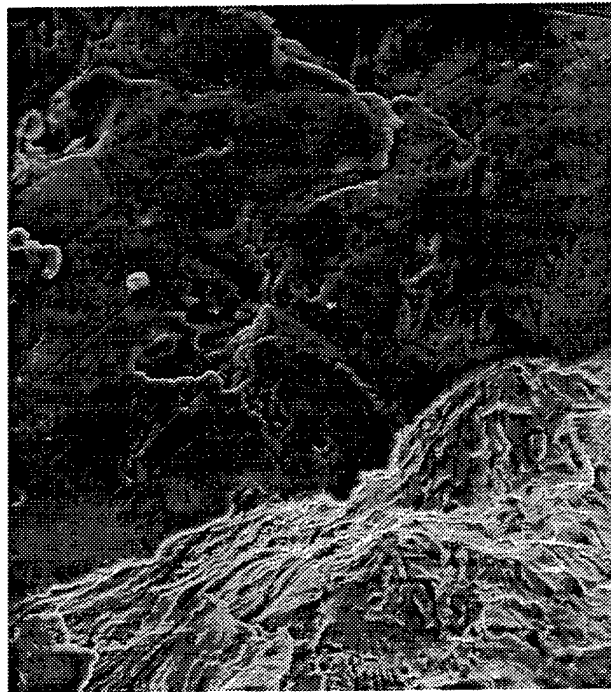
while Figure 20 is a magnification of this area showing intergranular surface attack adjacent to the origin. Beyond the fracture region, a small shear lip consisting of ductile dimples was observed, which represented final fracture. No inherent defects or gross inclusions were noted at the origin of the primary fracture. The topography of the secondary fracture was characterized by a smaller region of fatigue, with the remainder of the surface typical of overload. The fatigue morphology was characterized by a shiny appearance, in contrast to the overload region that displayed a dull texture. A shear lip encompassed the outer periphery of the fracture surface, except for the bushing wall. An intergranular morphology was evident at the fracture origin. Figure 21 shows the origin of the secondary fracture. The origin at an angle is shown in Figure 22. Figure 23 shows intergranular surface attack adjacent to the origin. EDS examination of the dark golden colored coating at Boeing revealed a level of chromium consistent with a chromic acid anodize.

Figure 20. Magnified SEM of Figure 19, Showing Intergranular Attack on the Surface of the Bore Adjacent to the Primary Fracture Origin; Magnification 200 \times .

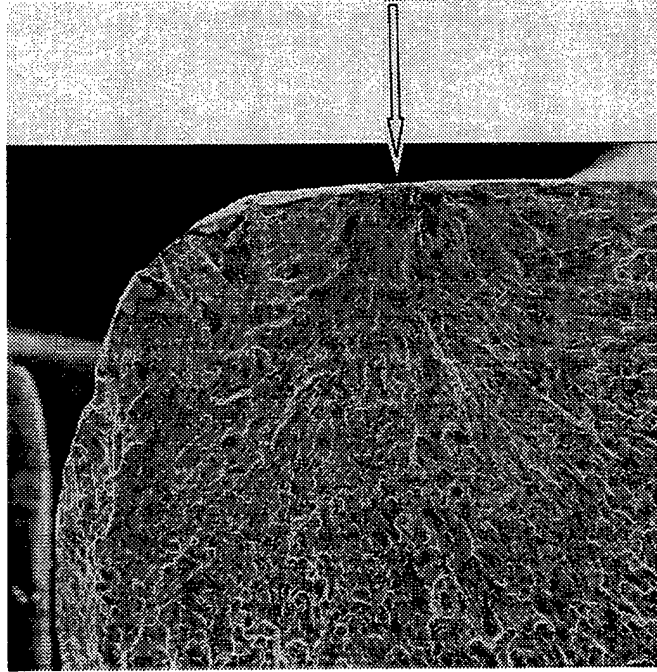
Figure 21. SEM of the Secondary Fracture Origin (Indicated by Arrow); Magnification 50 \times .

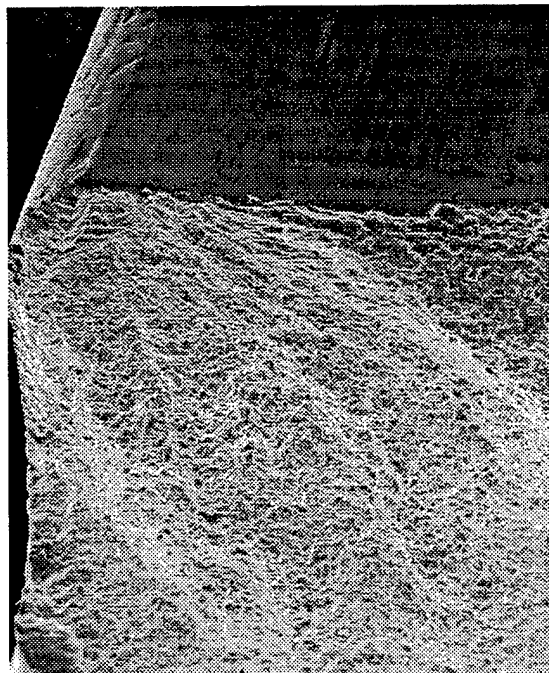
Figure 22. SEM of the Secondary Fracture Origin, Tilted at an Angle to Reveal the Surface of the Bore; Magnification 50 \times .

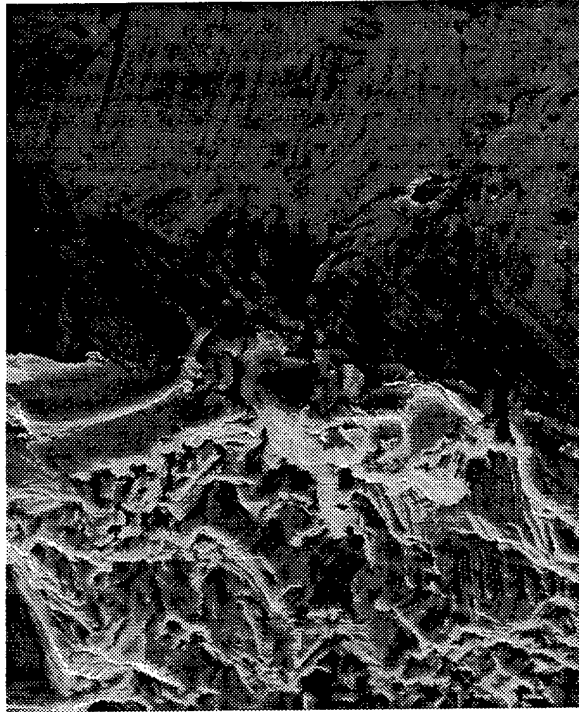
Figure 23. Magnified SEM of Figure 22 Showing Intergranular Attack on the Surface of the Bore Adjacent to the Secondary Fracture Origin; Magnification 500 \times .

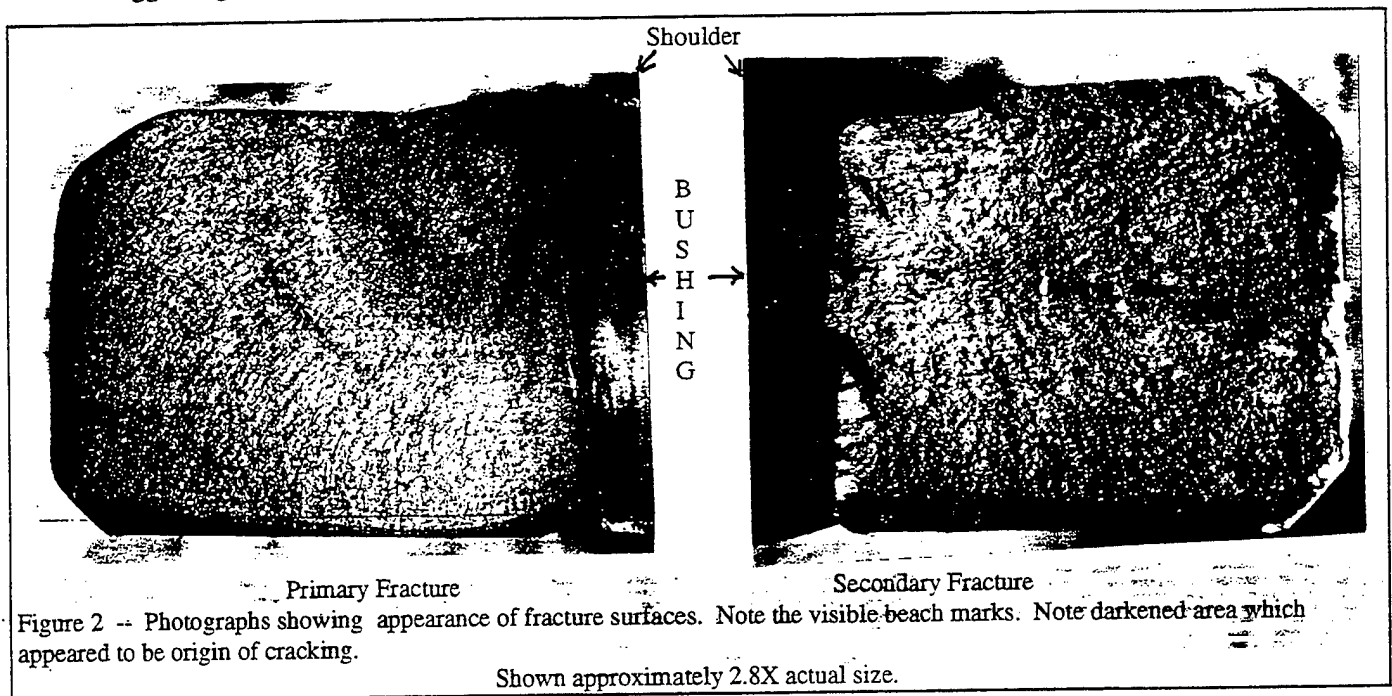
Inspection of the fracture surfaces (to both sides of the bearing) revealed yellow to brown coloration near the chamfered edge located on the top side (positioned under the shoulder of the bushing) of the bore. The coloration was much more pronounced on one fracture suggesting this fracture occurred first (hereafter referred to as the primary fracture). Beach markings, indicative of fatigue damage, appeared to have originated at, or near, the chamfered edge of this fracture. The beach markings were visible on approximately 75% of the fracture surface. Inspection of the second fracture (hereafter referred to as the secondary fracture) revealed a coarse texture suggesting this failure was primarily due to overstress. See Figure 2.

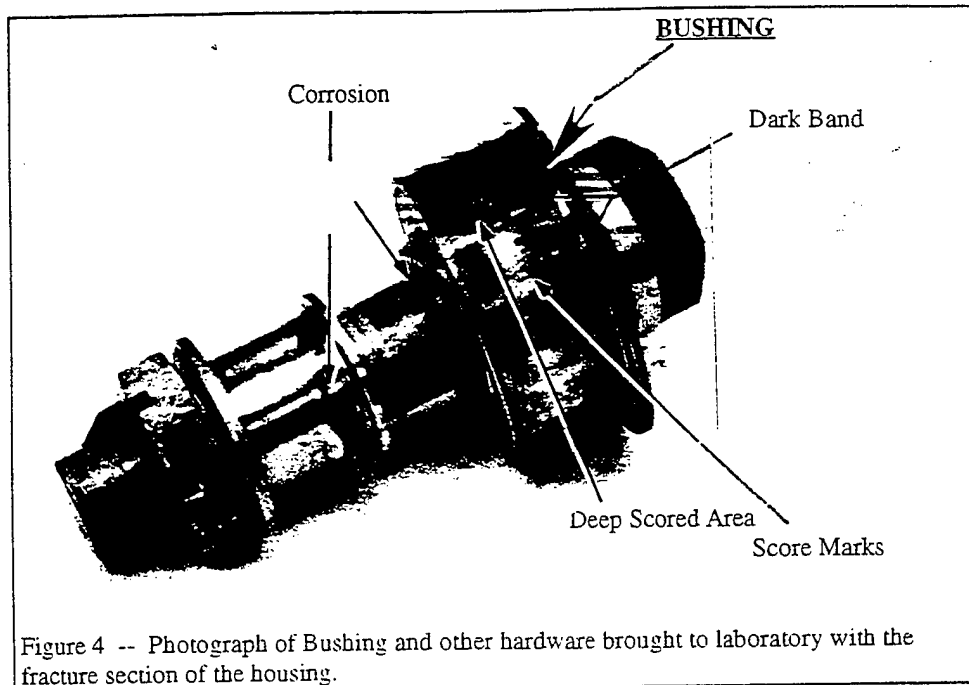
*** Evidence of fretting and slight pitting corrosion.

*** Evidence of corrosion to the other associated hardware (bolt, nut, etc.).

Figure 4 -- Photograph of Bushing and other hardware brought to laboratory with the fracture section of the housing.

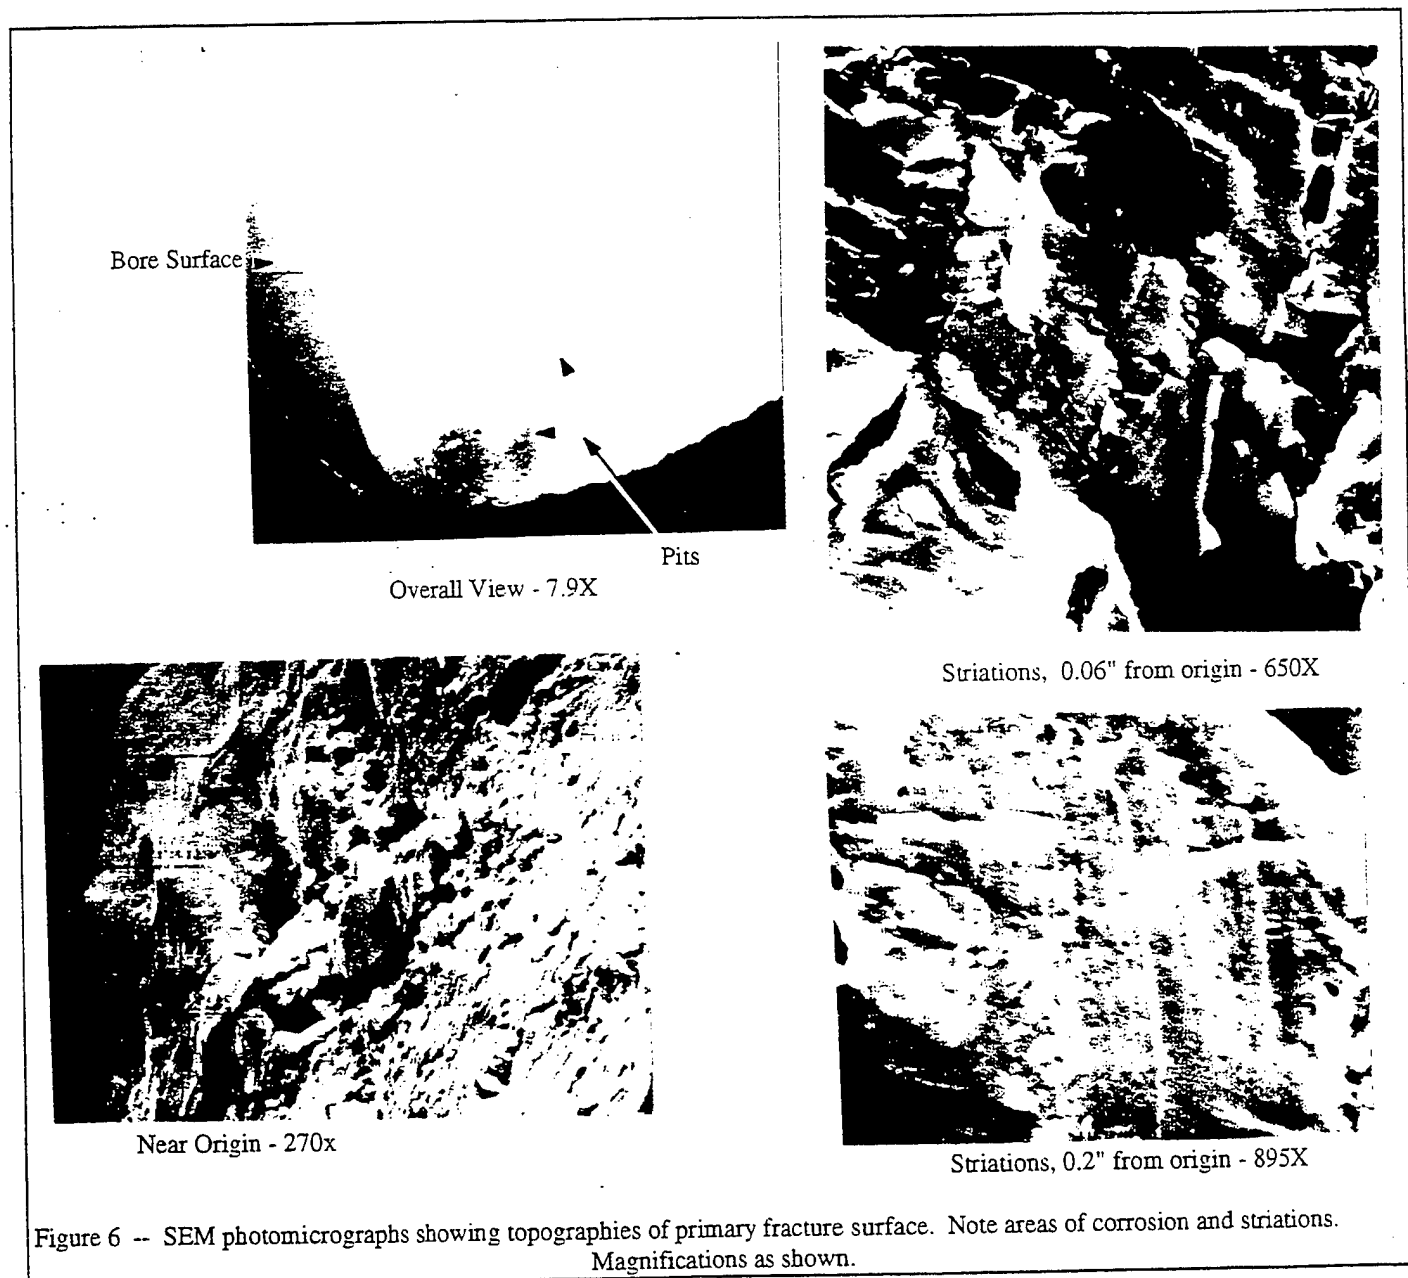
*** The striations, clearly visible at magnifications to 1000X, were present on 80-90% of the fracture surface. The final fracture, located on the diametrical opposite corner of the fracture surface, had a topography indicative of overstress.

Figure 6 -- SEM photomicrographs showing topographies of primary fracture surface. Note areas of corrosion and striations. Magnifications as shown.

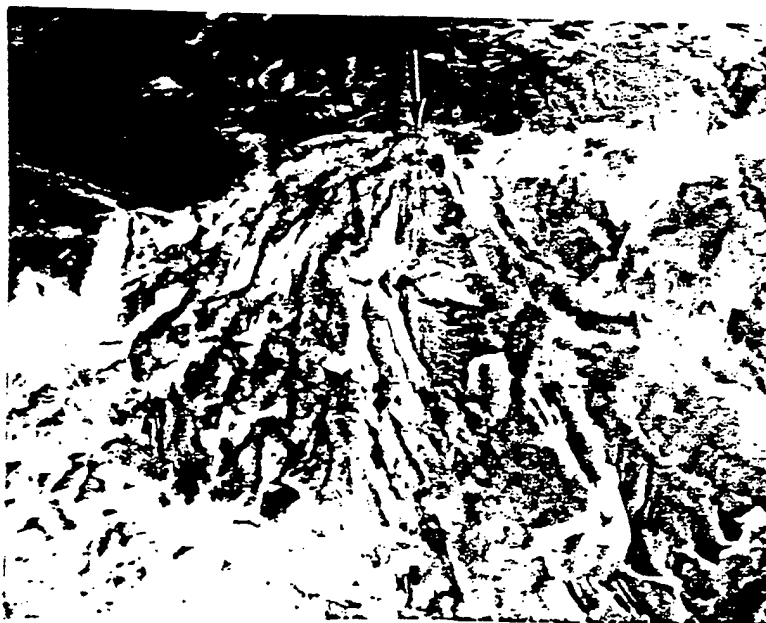
Figure 7 500X
Magnified SEM photograph of the primary fracture origin area (arrow). Note no anomalies are present.

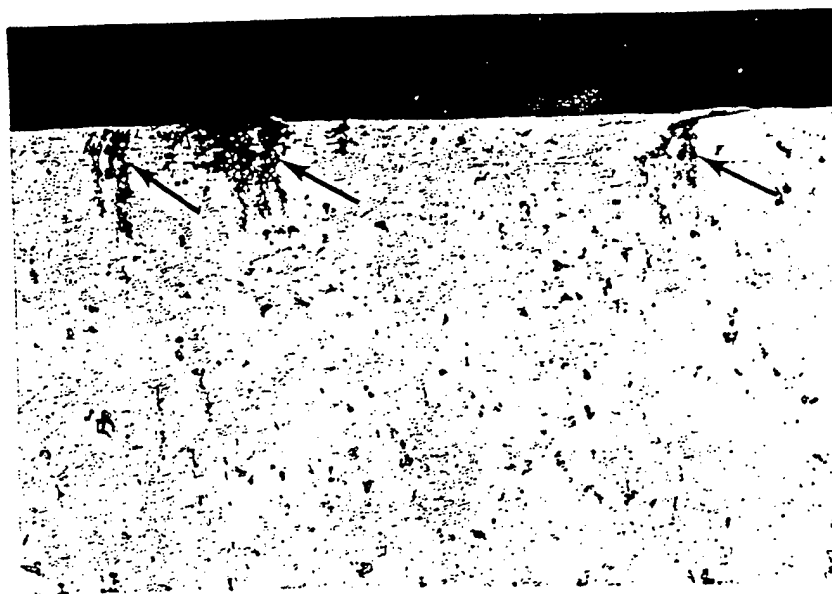
Figure 12 100X
Photomicrograph of a cross-section through the lug approximately 90°
from the primary origin, revealing intergranular corrosive attack (arrows)
extending from the bore surface.

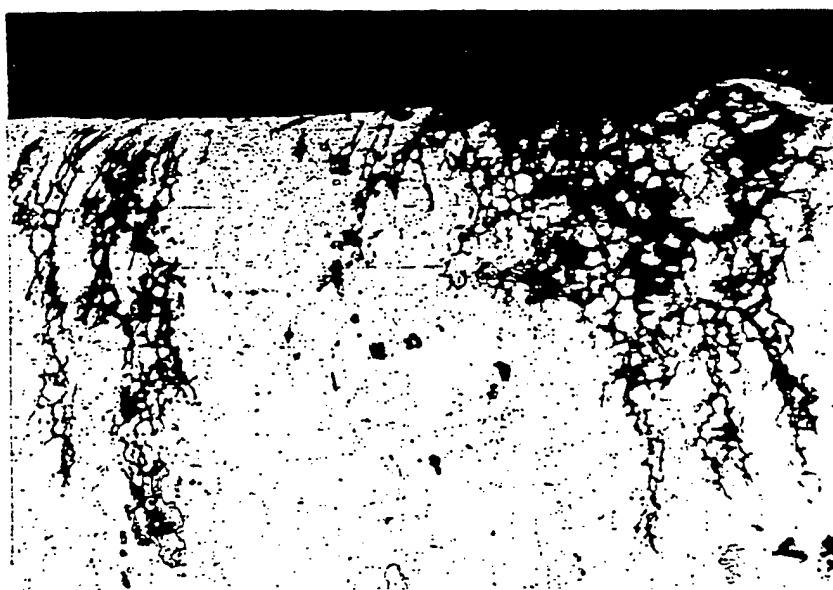
Figure 13 400X
Magnified view of the cross-section through the lug bore revealing
intergranular attack extending to an approximate depth of 0.006 inch.
